A Practical and Simple Keypad Bounce Filter for the Kenwood R-5000

This modification was reported in the Kenwood R-5000 Yahoo! Group by Ron Hankins (KK4PK). This documents my implementation of Ron's solution to this annoying and long lived problem with this otherwise good communications receiver.

Mike VE3JBT

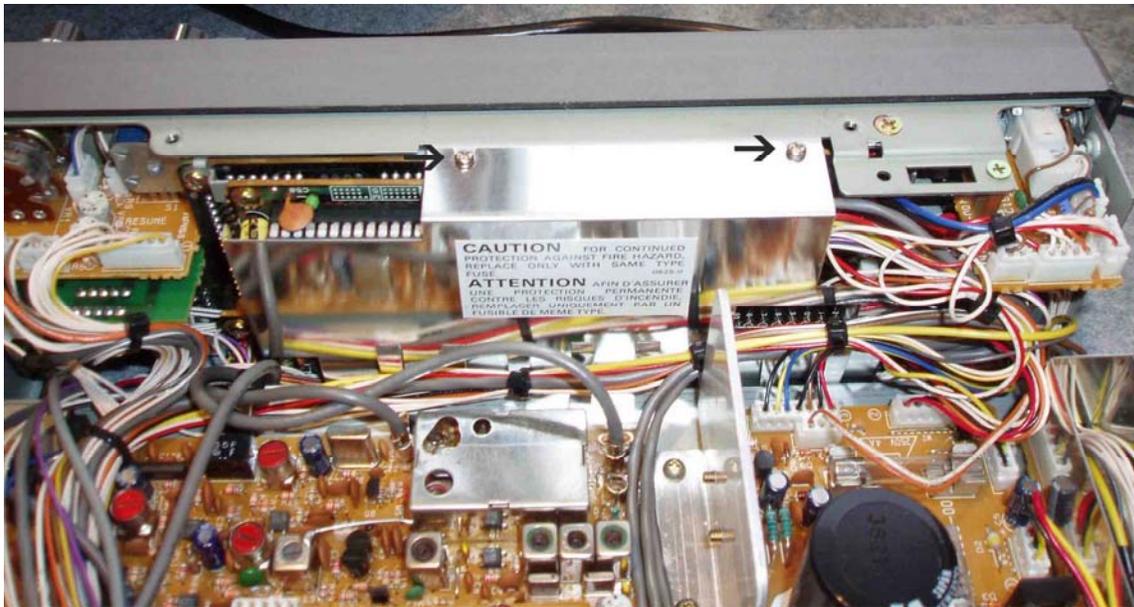
Remove the top and bottom covers and set them aside after disconnecting the speaker wire, Loosen but do not remove the small screws indicated by the arrows as shown in the two pictures below.

Top view

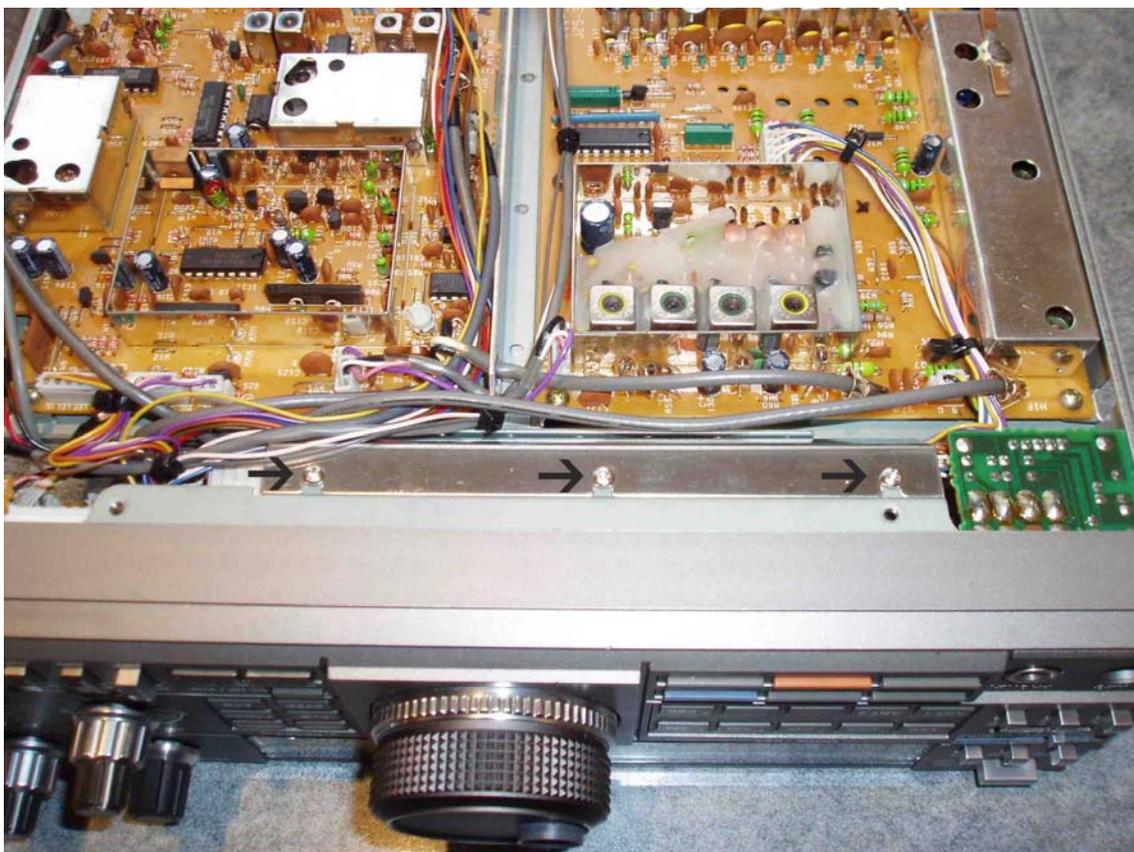
Bottom view

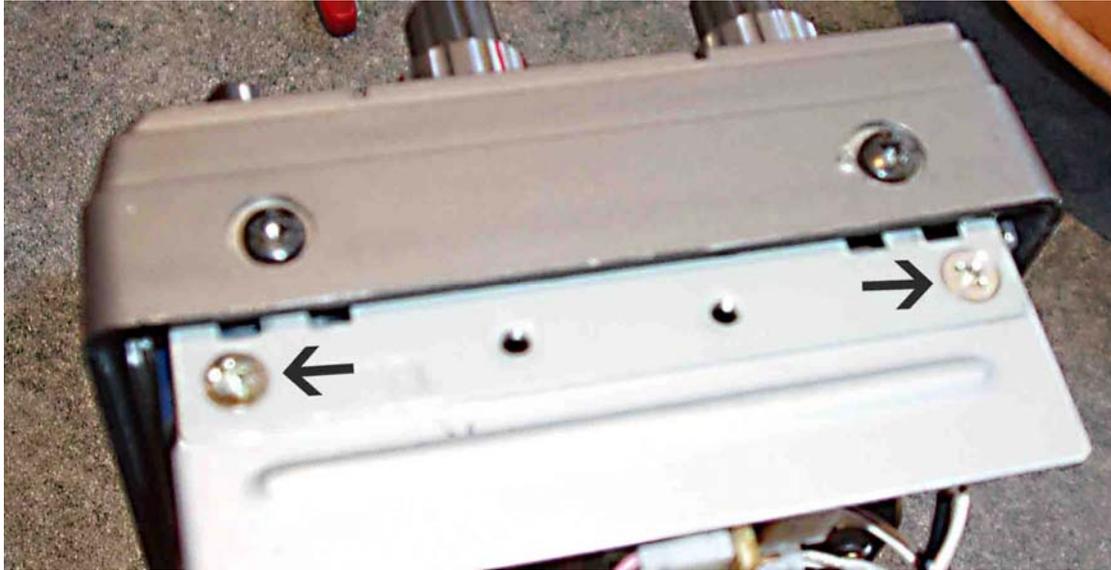
Remove the two countersunk screws holding the front panel in place as shown below.

Remove the screws from both sides and gently separate the front panel from the chassis. The shield can now be removed by sliding it towards the back and carefully removing it.

Front panel attachment screws

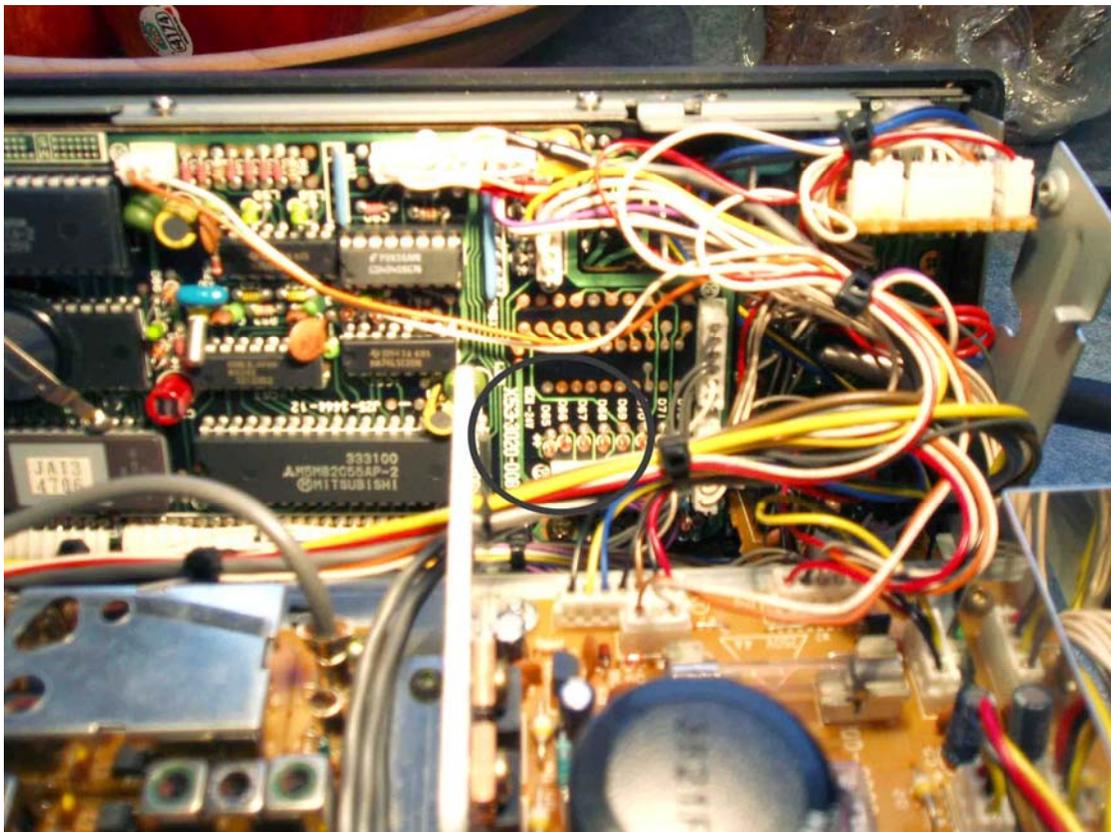
With the shield removed, you should be able to locate the circled area shown in the image below.

The area where the caps will be attached

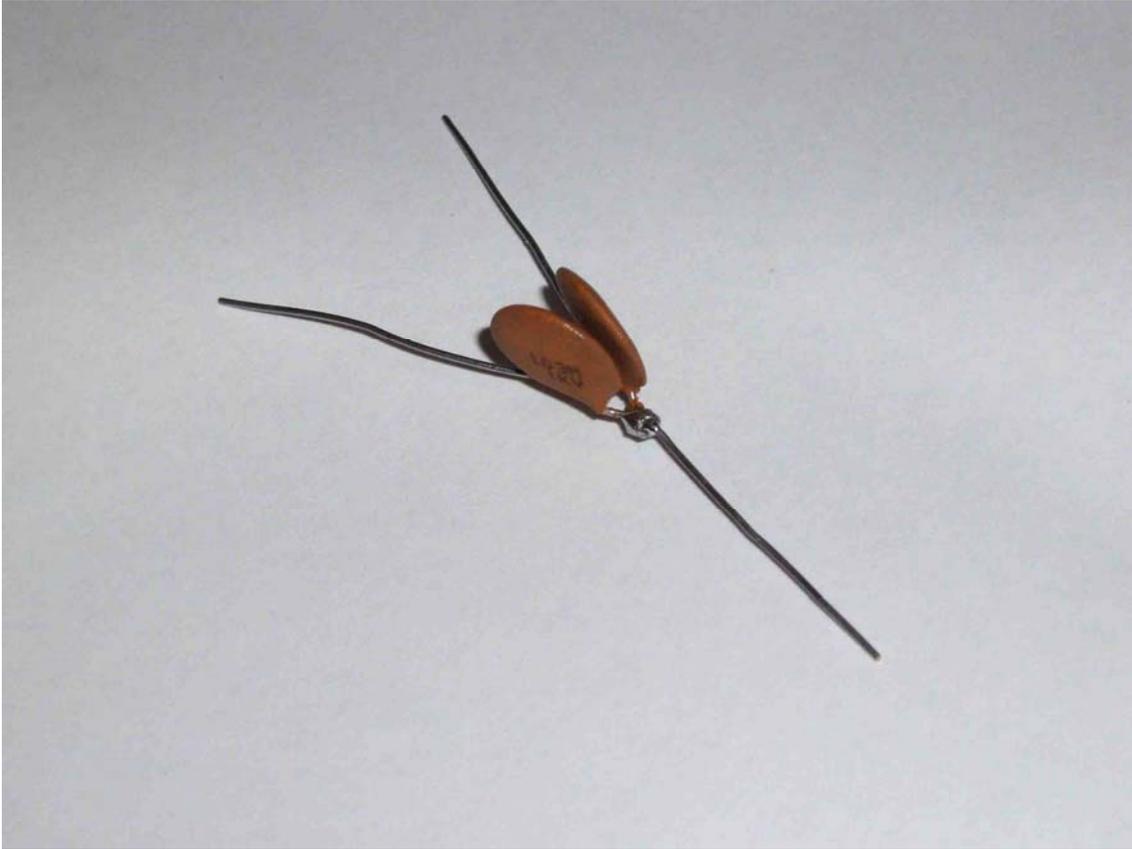
Preassemble two .01 ufd disc ceramic caps as shown in the picture below.

Capacitor assembly

My caps happened to be 1Kv types and were 10mm (3/8") in diameter.
Now turn the radio so the bottom side is up and locate the solder pad located between the pc board mounting screw and C52 as shown in the picture below

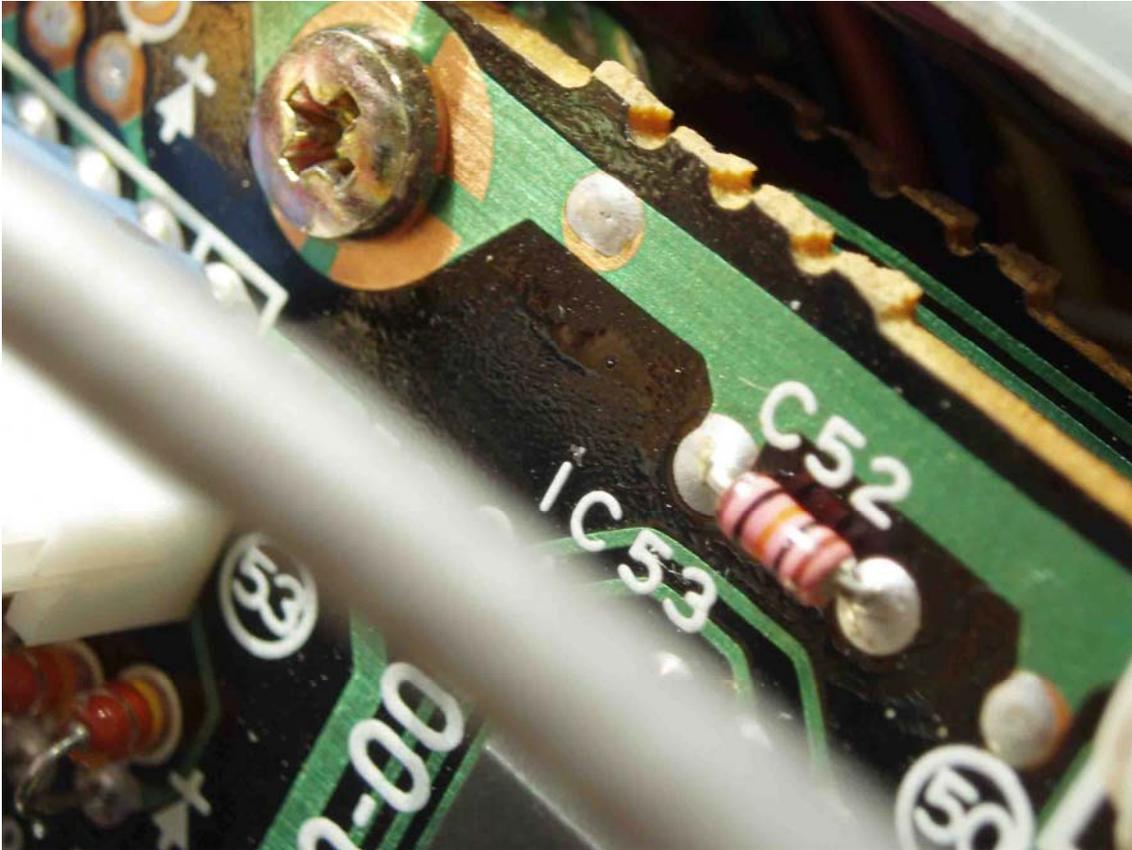
Ground solder pad

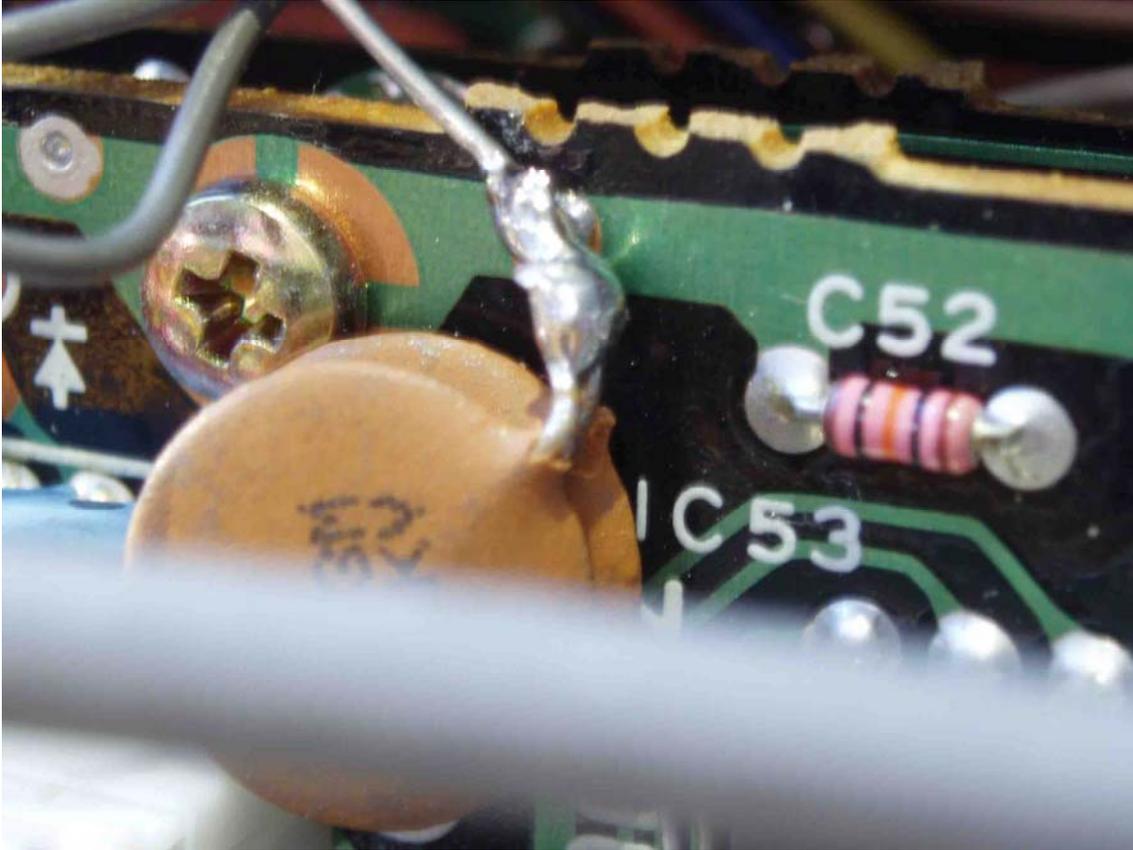
Using a small pencil soldering iron, tack a small blob of solder to this pad and attach the cap assembly as show below. Cut the wire tail off after you have made a good solder connection.

Capacitor assembly ground side attachment

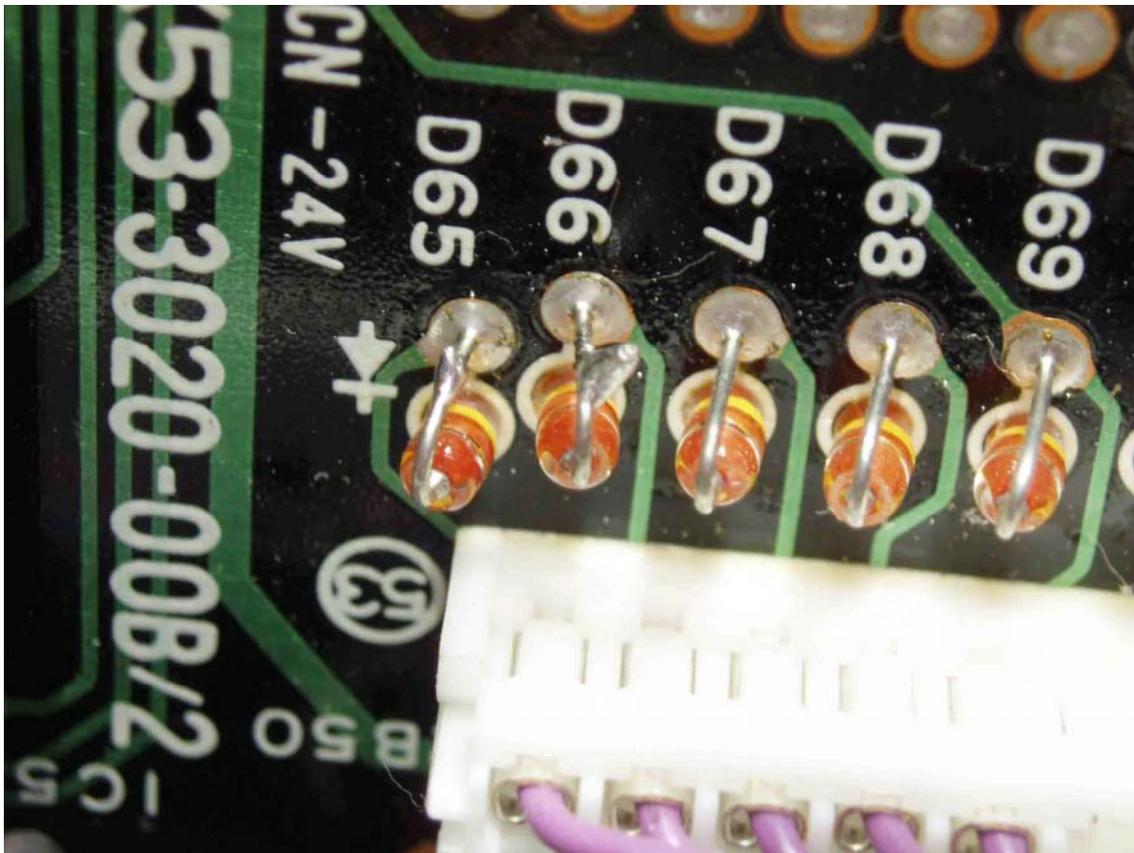
Now turn the radio right side up. and locate the anodes for diodes D65 and D66. Using a low wattage pencil iron, Tin the wire loops on these two diodes as shown below.

D65 and D66 Anode connections

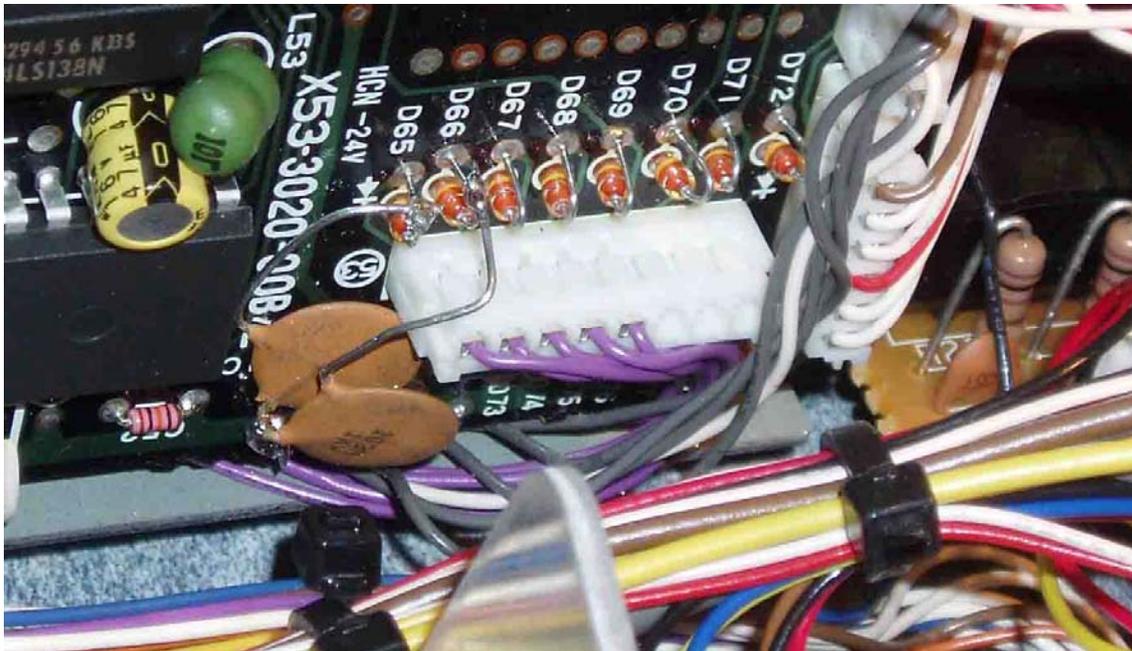
The final step is to solder the two remaining capacitor leads to the diodes. Carefully dress the capacitor leads so that they do not touch anything other than D65 and D66 anode leads.

Pre-tin the capacitor leads and tack them into place as shown below

D65 and D66 Attached to the caps
